PASSAIC RIVER BASIN
HIBERNIA BROOK, MORRIS COUNTY
NEW JERSEY

LAKE AMES DAM NJ 00337

PHASE 1 INSPECTION REPORT NATIONAL DAM SAFETY PROGRAM

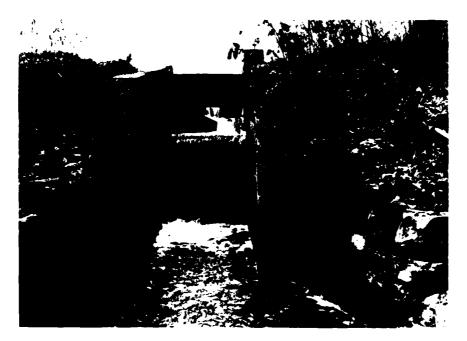
6 November 1979 Looking west at downstream face of stoplog spillway structure.

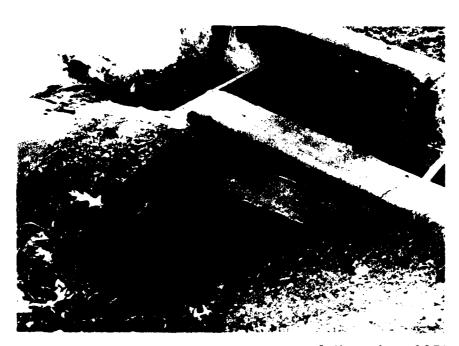
- c. <u>Visual Observations</u>. Erosion of the embankment section was noted adjacent to the south wall of the stoplog spillway. Water is passing through a hole in the stoplog structure concrete wall and discharging back into the spillway. The entrance to the spillway is almost completely blocked with debris. There was no visual evidence of damage to the structure caused by overtopping.

6 November 1979 Looking northwest across stoplog spillway structure. Note leak through main dam wall and cracking and spalling of concrete.

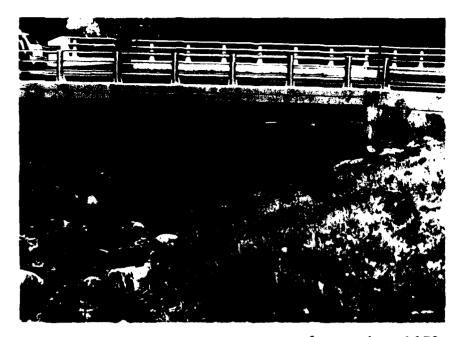
6 November 1979 Looking downstream from N.J. Route 513 bridge at second bridge encountered downstream of dam.
